Maryland Historical Trust Determination of Eligibility Form

Property Name: Bridge No. D-028
Address: Backlanding Road over Hunting Creek
City: Preston **Zip Code:** _____
USGS Quadrangle(s): Preston
Property Owner: Dorchester County Department of Public Works
Tax Map Parcel Number(s): _____
Project: Replacement of Bridge No. D-028
Agency Prepared By: MHT
Preparer's Name: Tim Tamburrino
Documentation Is Presented In: MIHP Form D-709 completed during the Historic Bridge Inventory in 1995
Preparer's Eligibility Recommendation: _____ **Eligibility Recommended** ☒ **Eligibility Not Recommended**
Criteria: ☐ A ☐ B ☐ C ☐ D **Considerations:** ☐ A ☐ B ☐ C ☐ D ☐ E ☐ F ☐ G
Complete if the property is a contributing or non-contributing resource to a NR district/property:
Name of the District/Property: _____
Inventory Number: _____ **Eligible:** ☐ Yes ☐ No **Listed:** ☐ Yes ☐ No
Site Visit by MHT Staff: ☐ Yes ☐ No **Name:** _____ **Date:** _____

MHT No. D-709

Bridge Name Backlanding Road over Hunting Creek

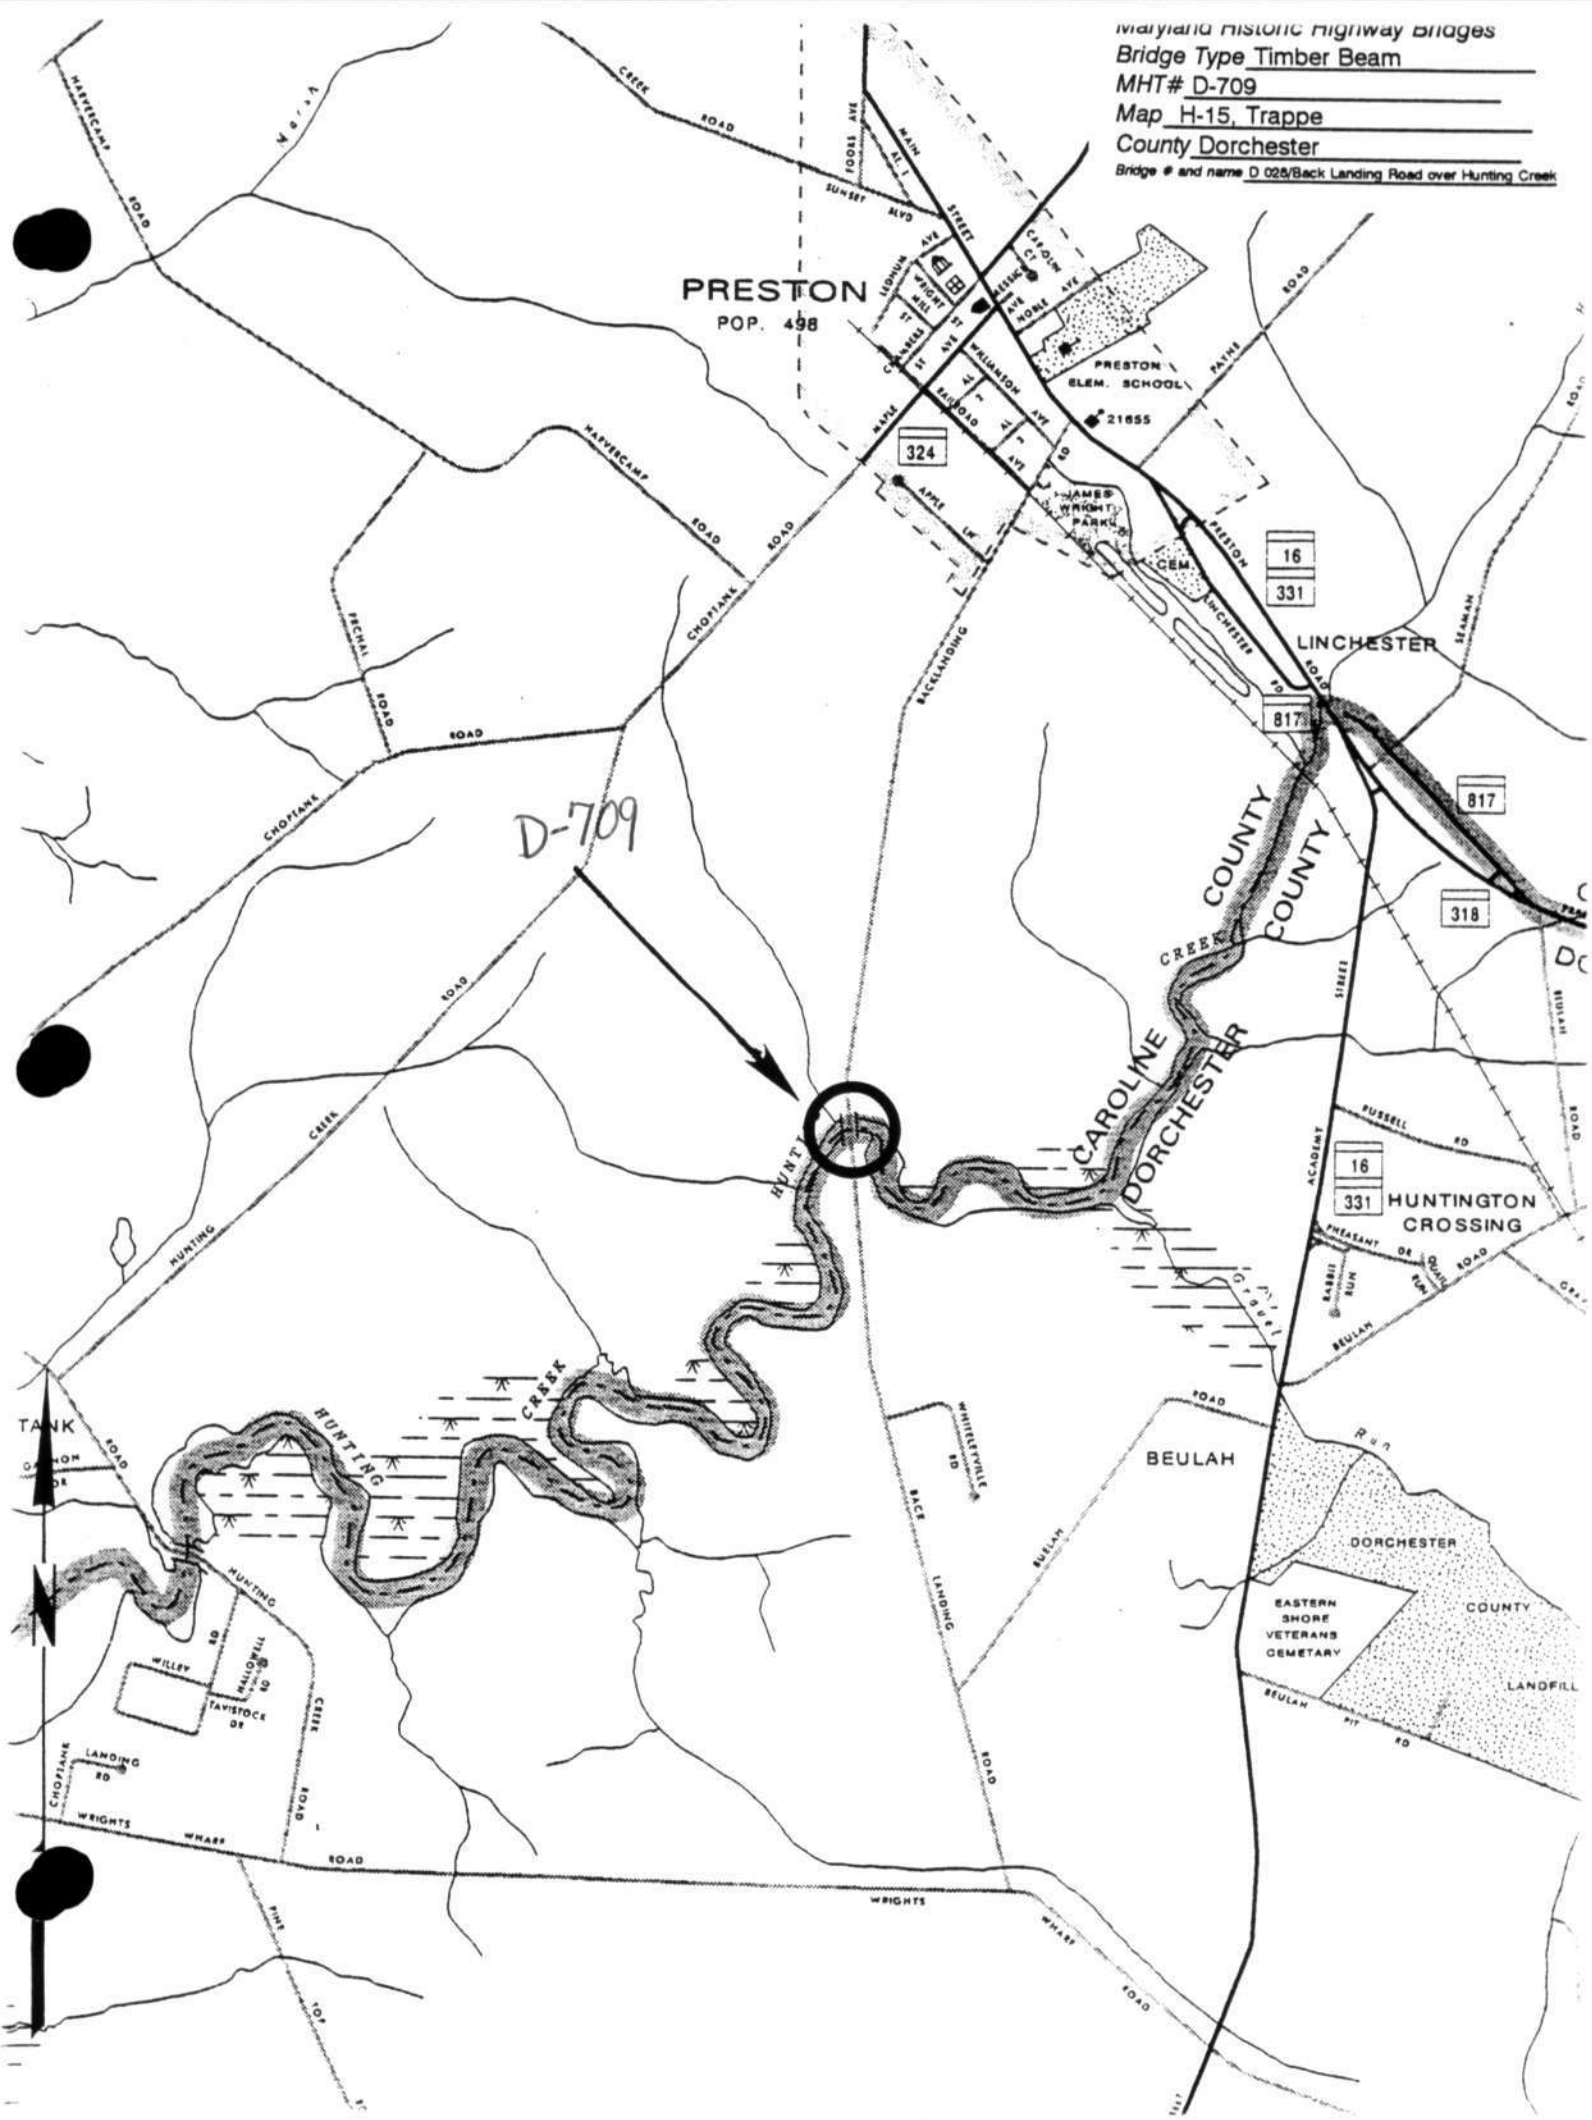
- 1 D-709
- 2 Back Landing over Hunting Creek
- 3 Dorchester County, MD
- 4 3/98
- 5 Marris German, WMA
- 6 MD SHPO
- 7 Elevation looking west, south half
- 8 1 of 4
